**United States Coast Guard**  
**Office of Investigations and Casualty Analysis**  
**Safety Alerts, Safety Advisories, Lessons Learned**  
**2008-2012**

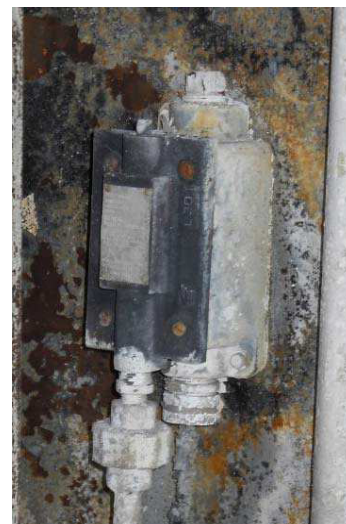
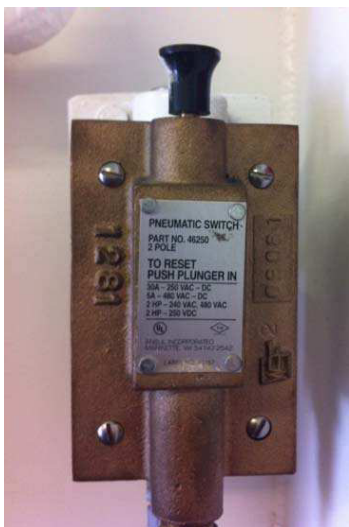
Recently, a vessel with an installed fixed CO<sub>2</sub> fire suppression system, suffered extensive damage due to a fire that started in the engine room. During the firefighting efforts the crew reported that the engine room ventilation could not be secured. A post casualty damage survey of the vessel revealed that the pressure switch used to secure the ventilation was located within the engine room. See the photograph of the damaged pressure switch at the right and new switch below.

Fixed CO<sub>2</sub> systems on inspected/regulated vessels need to be type approved and installed in accordance with applicable regulations; 46 CFR 25.30-15, 46 CFR Subpart 76.15, 46 CFR Subpart 95.15, 46 CFR 118.410, etc. These regulations require all controls and valves for the operation of the system to be outside the space protected, and notes they cannot be located in any space that might be cut off or made inaccessible in the event of fire in the protected spaces. The Coast Guard considers pressure switches that are used in such systems a "control."

The Coast Guard ***strongly reminds*** Owners and Operators of vessels with installed fixed fire suppression systems to ensure that these switches are properly located aboard their vessels. If the pressure switch or switches are located within the space being protected, they should be relocated by a properly trained fire suppression service technician. Doing so will assist in ensuring system functionality and accessibility in the event of an emergency. Failing to do so could have serious consequences to the vessel, its crew and the environment.

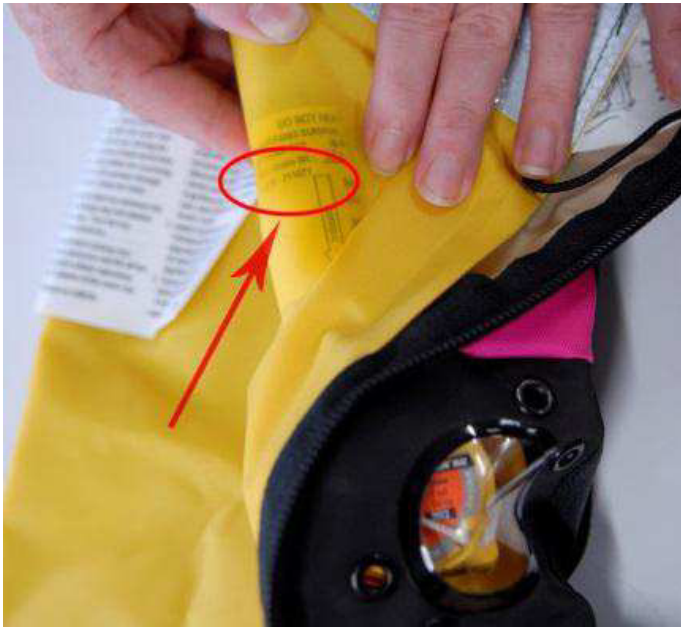
Photograph showing view of lot number through fabric.

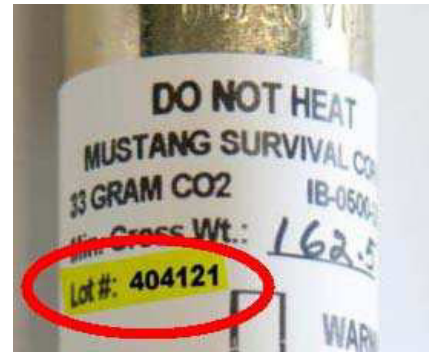
Lot number on cylinder label.

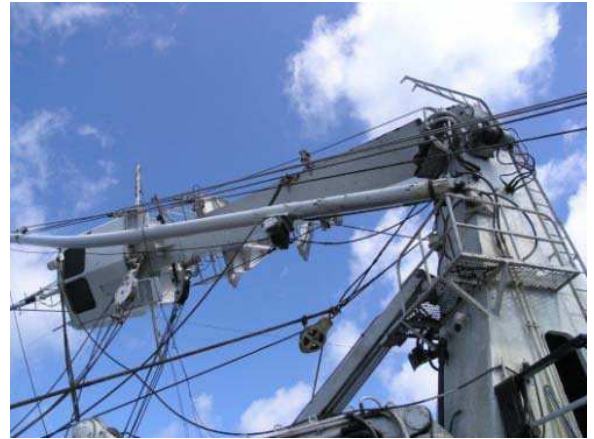
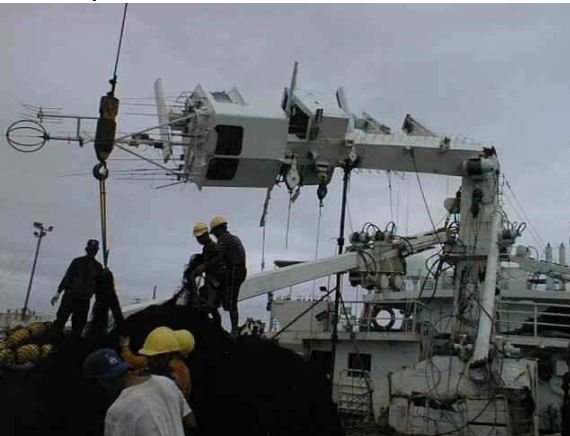
Recently, several catastrophic failures of masts, booms, and lift cables have occurred on purse seine fishing vessels that have resulted in loss of life and severe injuries. Over the years many casualties have occurred onboard all types of fishing vessels attempting to haul in catches that exceeded the capacity of their winches, hoists, and associated equipment. These types of casualties are not unusual. This alert serves to remind all purse seine fishing vessel owners/operators and other fishing segments to ensure safe use of the haul equipment particularly matching the size and the capacity of the nets to the rated size and capacity of the winch/haul/hoist equipment, taking into account safety factors for various species, and other concerns such as the variable platform that a rolling fishing vessel and variable catch presents.

- Know the design limits of load bearing structures and winches, hoist, and haul components;
- Ensure they are not modified by crew members; properly maintained; and are inspected and tested on a regular basis. Repair/replace components immediately when deficiencies are discovered;
- Evaluate and revise operational procedures as needed.

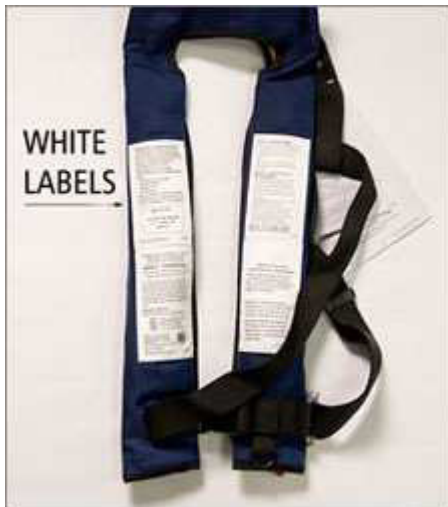
Product with white labels are **not** part of this recall.

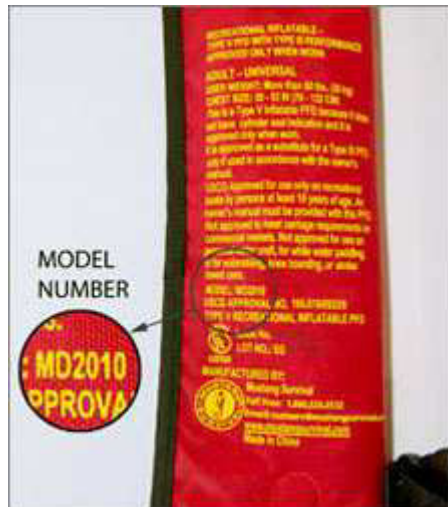
#### **Image 2**

Check for the model number on the back of the PFD above the UL logo.

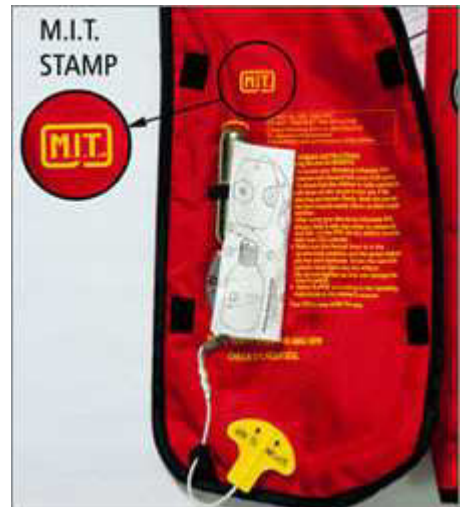
#### **Image 3**

Any MD2010 or MD2012 with an "MIT" stamp is OK to use and does not need to be returned.

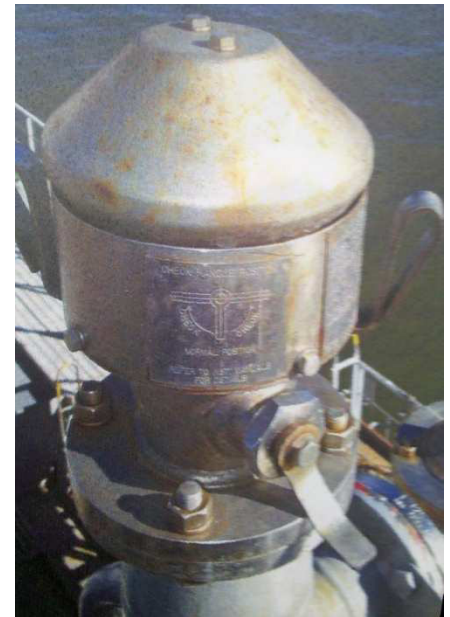
The investigation is nearly complete and investigators have identified several causal factors, one being the failure of the high velocity vent valve which did not open and prevent over pressurization of the tank while it was being filled.

After this specific casualty, the high velocity vent valve of the tank being filled was found stuck closed and inoperable using the manual test lever. A valve for another tank was also found stuck. Scientific testing of the substance between the stuck valve disc and the seating surfaces indicated the presence of oxidized vegetable oil or fat likely from previous cargos. It appears doubtful that crewmembers exercised the valves prior to their cargo operations as per their operating procedure.

As a result of this casualty and others involving similar circumstances, the Coast Guard **strongly recommends** to vessel Owner / Operators, Crewmembers, Classification Society Inspectors, Vetting, and other inspection personnel ensure that tank high velocity vent valves and vacuum valves, or combination pressure / vacuum valves are maintained in operating conditions at all times and are routinely checked as procedures require.

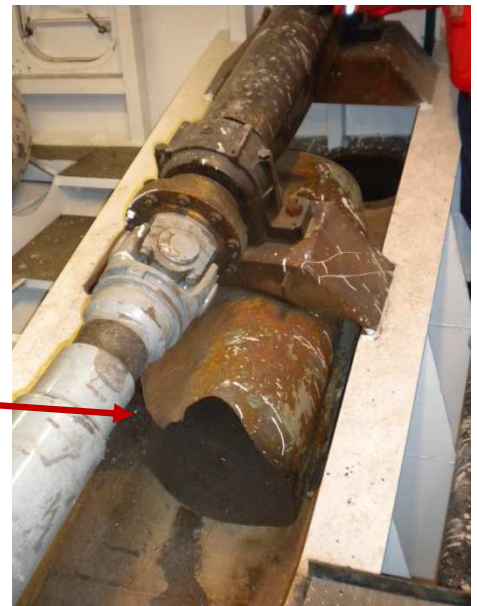
Not long ago, an air receiver unexpectedly ruptured with terrible results onboard an UTV on the Upper Mississippi River. A crewmember was seriously injured and paralyzed. Several causal factors were noted during the casualty investigation; the lack of a relief valve to protect the system and significant corrosion within the receiver. It's important to note that on unprotected systems, all it takes for the system to be over-pressurized is for the compressor's pressure switch/contacter or unloader to fail and not shut off the machine. Further, internal corrosion on aged tanks present a latent unsafe condition and may go unnoticed if not inspected.

(Parted air receiver.)

As a result of this casualty and other similar incidents, the U. S. Coast Guard **strongly recommends** that UTV Owner/Operators, vessel engineers, insurance surveyors and other inspectors **ensure** that:

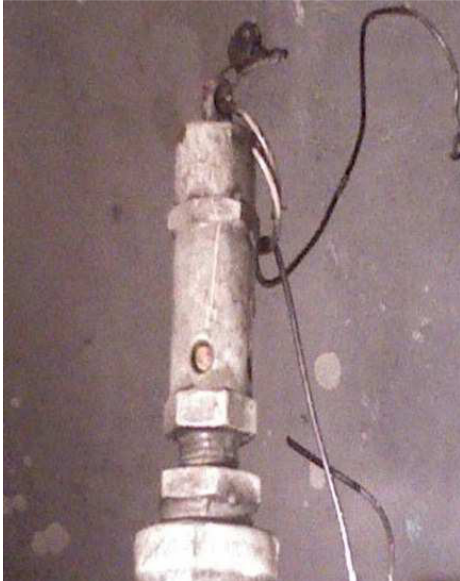
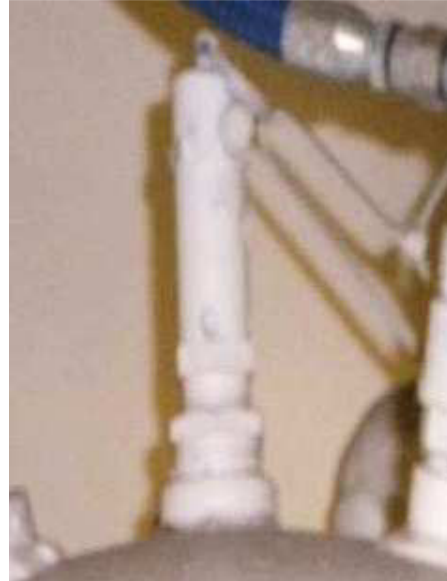
- Pressure relief devices are not capable of being isolated or their operation prevented by being wired or secured in a position that prevents the valve from opening;

**RELIEF VALVES MUST NEVER BE SECURED IN THE CLOSED POSITION**

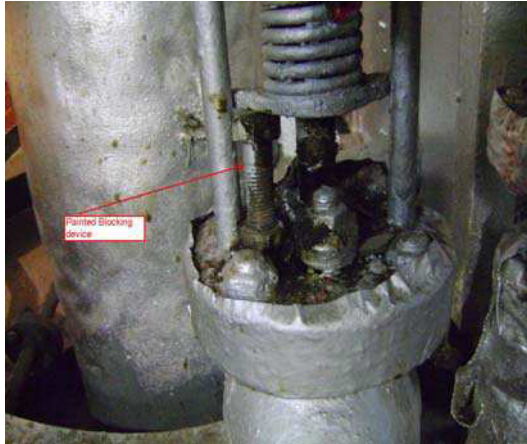
QCV blocked utilizing a bolt to hold in the open position. (Note: the painted portion on the bolt indicating possible long term condition.)

The U.S. Coast Guard **strongly recommends** that owners /operators, vessel engineers, PSCOs, Class society and other machinery space inspection personnel ensure:

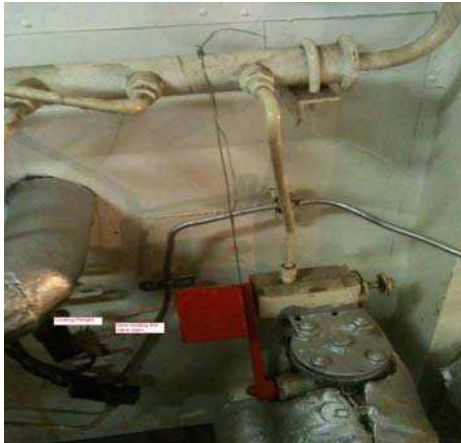
QCV blocked utilizing wire to hold closing weight up and the valve in the open position.

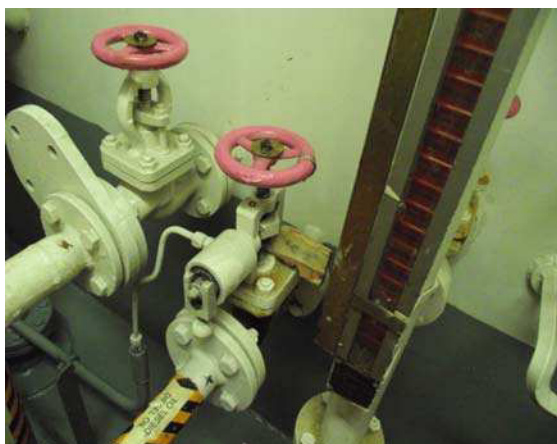
QCV blocked utilizing a wooden block to hold the valve in the open position.

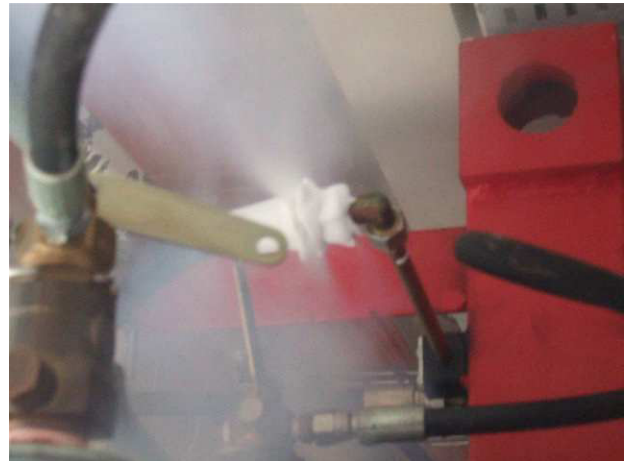
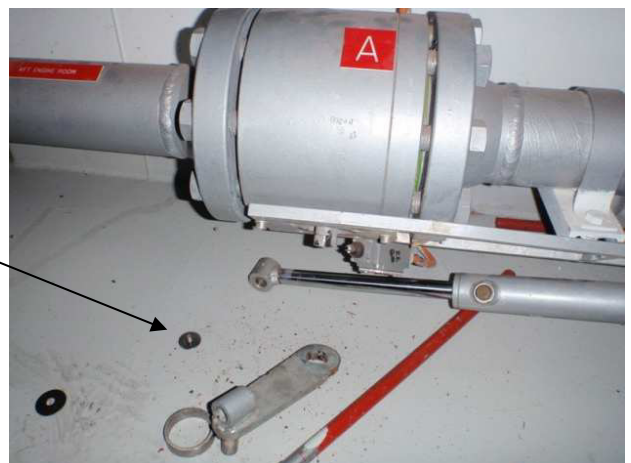
- Numerous piping and hose connections leaked extensively. When the system was activated, on scene video taken by the firefighters showed numerous leakages into the CO2 room. Post casualty, while pressure was still on the system, some of these leaks continued even after the connections were tightened. (Photograph at right.)
- The zone valve for the aft machinery space which admits CO2 from the bottle bank manifold to the space failed. Specifically, the ball valve's opening actuating arm fell off the valve when the gas powered piston actuator attempted to move it. The ball valve actuating arm was held in place by a very small machine screw and washer. When firefighters attempted to open the valve manually using the provided hardware it could not be moved. The valve was only able to be moved after the gas pressure was relieved from the inlet side of the valve. (Photograph at right.)

Because of these and other issues, the United States Coast Guard **strongly recommends** that Vessel Builders / Shipyards, Classification Societies, Insurers, Owners / Operators, System Service Personnel, and others involved with these systems:

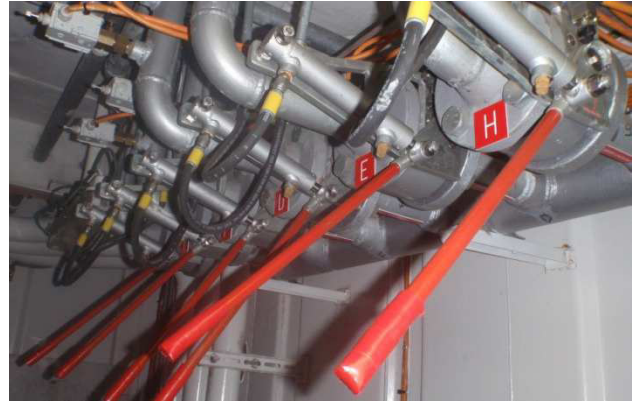
- Actuating arms to five of the six other zone valves were found loose. They were also attached by small machine screws. (Photograph at right.)

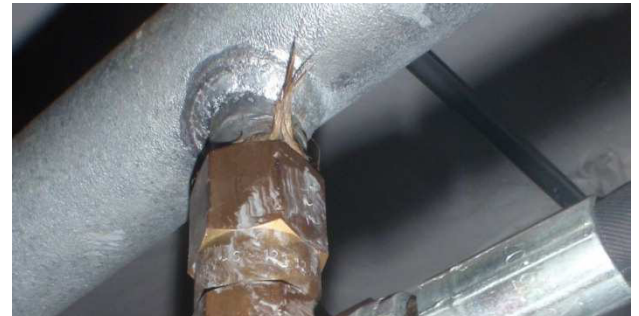
- Hemp type pipe sealant was used extensively on pipe threads throughout the system and in some instances seems to have entered the system. (Photograph at right.)

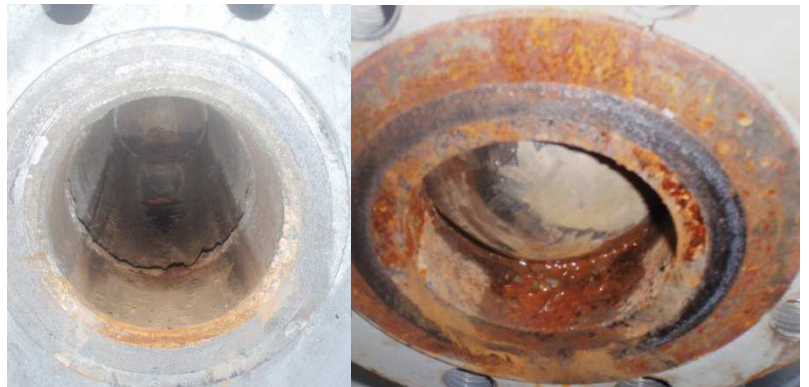
- Certain elements of the distribution manifold contained low points which allowed the accumulation of water within piping that could not be drained. Such a circumstance could cause corrosion that could possibly negatively effect operation of other components. (Photographs at right.)

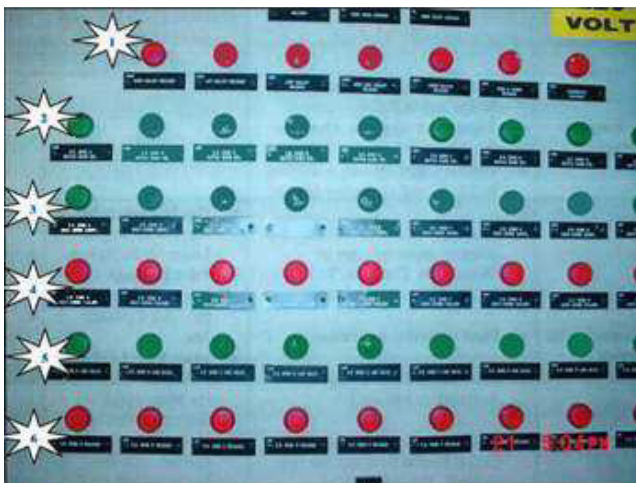
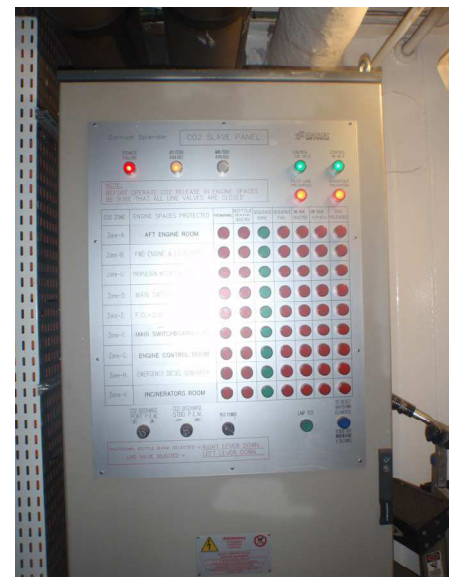
- Shipyard commissioning test procedures appear to differ from procedures documented in the vessel's Firefighting Instruction Manual (FIM). Commissioning procedures indicate that the discharge line selection to a specific protected zone should be made prior to releasing the gas contrary to the directions in the FIM.
- The FIM refers extensively to a Control Panel (left following image) that differs vastly from the one onboard the vessel (right following image).

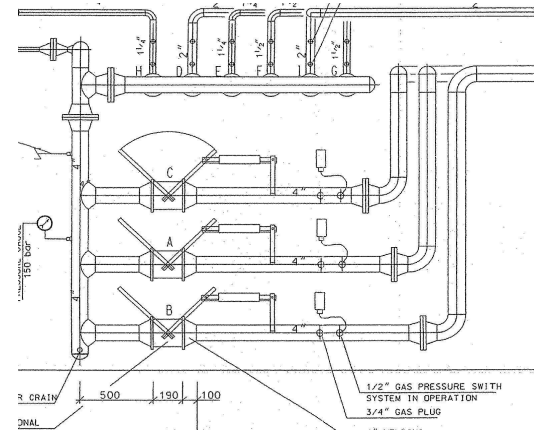
- Shipyard piping schematics and drawings do not appear to match the actual installation. The schematic at the right shows the “A valve” for the Aft Machinery Space in the center position vice the bottom position as it is installed on the vessel.

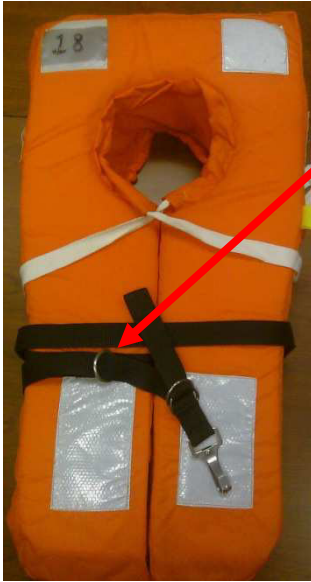
Recent Coast Guard inspections of Type I Personal Flotation Devices, (PFDs) in both adult and child size, identified a potential hazard that could prevent proper donning in the event of an emergency. The chest strap was threaded through the fixed "D" ring that the strap is intended to clip to when worn. *(Image left)*

The Coast Guard **strongly recommends** that vessel owners/operators using the PFDs listed above check each lifejacket for proper routing of the strap. Completely unwrap the primary strap to ensure it is free and capable of being adjusted for any wearer. The strap of the lifejacket must not be threaded through the fixed "D" ring. If routing is satisfactory, the strap may be wrapped around the life jacket and clipped to the fixed "D" ring for storage. *(Right image)* If the strap is incorrectly threaded through the fixed "D" ring, the snap hook assembly should be carefully removed from the strap, the strap pulled out of the fixed "D" ring, and the snap hook assembly re-attached.

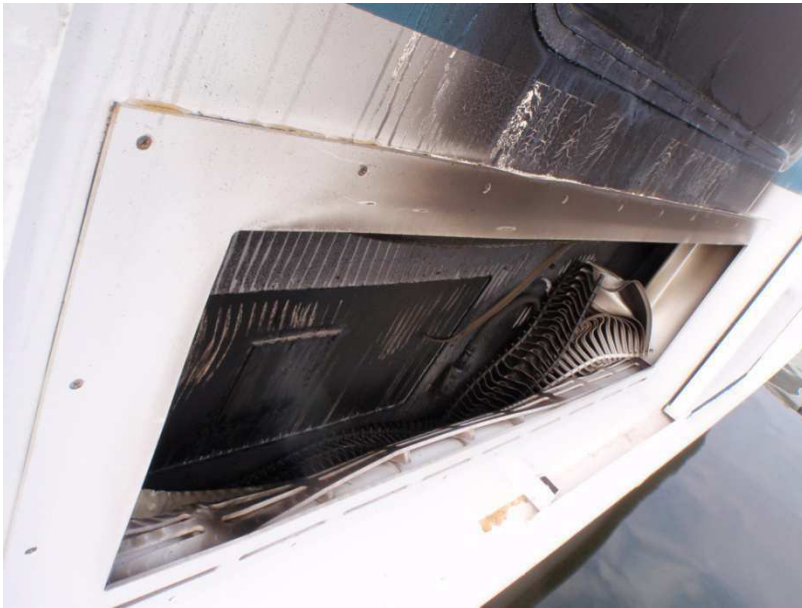
noted that if the filter had melted and fallen on or into the slot of the duct before the damper closed, it is likely to have interfered with the damper operation and possibly have reduced the effectiveness of the CO2 system.

46 CFR 116.610 (b) applicable to this vessel, states that “a ventilation duct, and materials incidental to installation must be made of noncombustible material.” 46 CFR 116.610(c) states that “combustibles and other foreign materials are not allowed within ventilation ducts. However metal piping and electrical wiring installed in a metal protective enclosure may be installed within ventilation ducts, provided that the piping or wiring does not interfere with the operation of fire dampers.” Owners and operators of any type vessel, as well as those persons involved with the inspection of vessels should be aware of the potential risks associated with this and similar installations and are reminded that

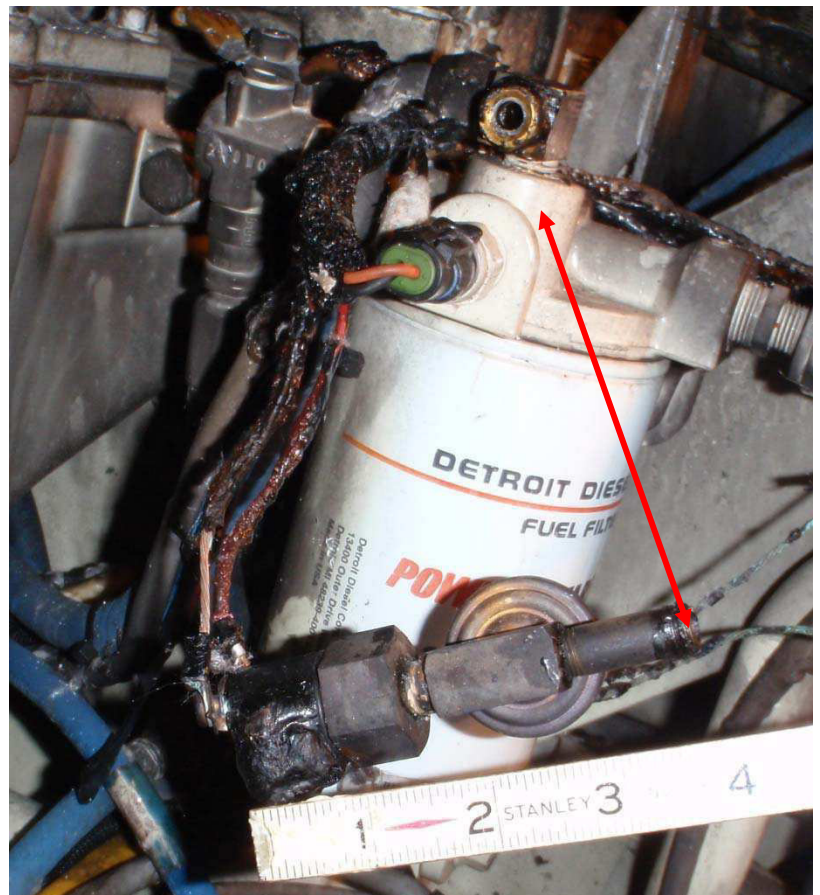
As stated previously, the investigation into this casualty is not yet complete. The components of the pipe fitting which failed are currently being examined by NTSB metallurgists. It is suspected however that the failed fittings may have been subjected to excessive vibration which could have caused the fracture. The original configuration was modified by adding a fitting that attached two additional sensors (for a total of four) to the fuel filter assembly and was subject to pressures up to 65 psig or greater. The assembly weighed 6.3 ounces and extended about 4 inches out of a reducing bushing that was threaded into the inlet fitting of the filter. Because of the location of the fire and oil soaked insulation it is

suspected that the fitting leaked first and did not immediately shear as shown in the photo at the right.
