**United States Coast Guard**  
**Office of Investigations and Casualty Analysis**  
**Safety Alerts, Safety Advisories, Lessons Learned**  
**2008-2012**

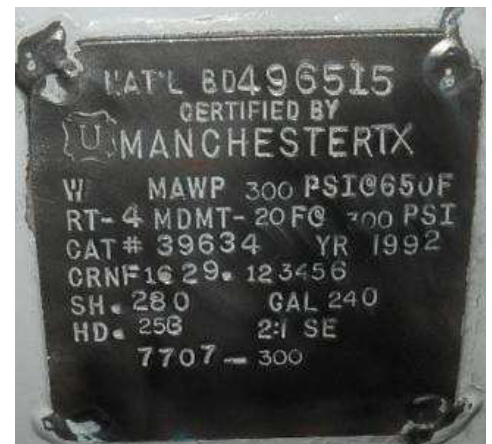
- A proper sized pressure relief device is installed on all air receivers. The pressure relief device should not be rated higher than the Maximum Allowed Working Pressure (MAWP) stamped on the air receiver's data plate;
- A data plate is attached to the receiver and pressure relief devices. If missing or damaged the UTV representative should provide evidence to prove the components were constructed to an approved standard. Otherwise this equipment should be taken out of service or replaced;
- The data plate associated with the receiver and pressure relief device remain unpainted and legible. Take care to minimize damage to the plates if paint needs to be removed. Pressure relief devices should not be painted as paint can interfere with the lifting of the valve. Those that are painted should be lift tested to ensure proper operation;

- Pressure relief devices are not capable of being isolated or their operation prevented by being wired or secured in a position that prevents the valve from opening;

**RELIEF VALVES MUST NEVER BE SECURED IN THE CLOSED POSITION**

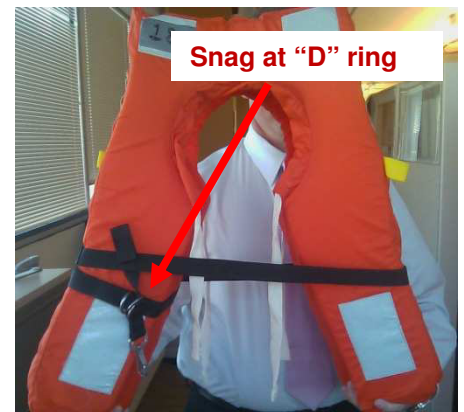
The Coast Guard **strongly recommends** that vessel owners/operators using the PFDs listed above check each lifejacket for proper routing of the strap. Completely unwrap the primary strap to ensure it is free and capable of being adjusted for any wearer. The strap of the lifejacket must not be threaded through the fixed "D" ring. If routing is satisfactory, the strap may be wrapped around the life jacket and clipped to the fixed "D" ring for storage. *(Right image)* If the strap is incorrectly threaded through the fixed "D" ring, the snap hook assembly should be carefully removed from the strap, the strap pulled out of the fixed "D" ring, and the snap hook assembly re-attached.

Vessel owners/operators are also encouraged as part of general preventative maintenance to verify that all their PFDs are in fully serviceable condition with an inspection of the straps, components, fabric and flotation material. Any significant deterioration in condition or poorly functioning hardware indicates a replacement is necessary.

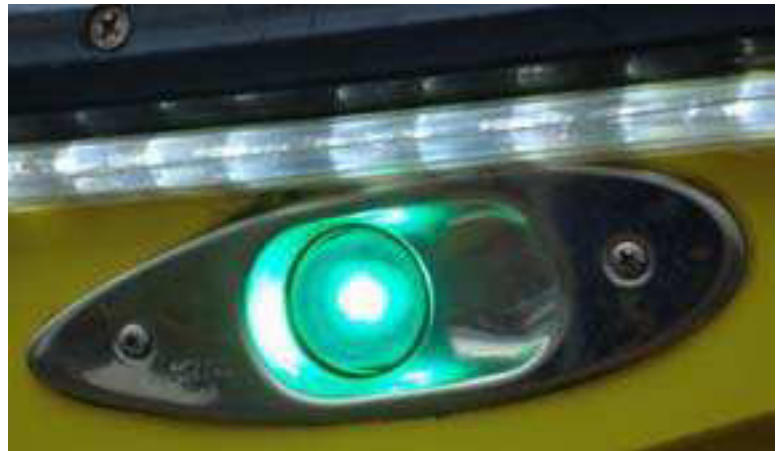
The Coast Guard recognizes that many vessel owners choose to place decorative lights onboard their vessels during the Holiday season. The Coast Guard **strongly reminds** vessel owners not to illuminate such lights during routine navigation unless operating in a Holiday boat parade or when the vessel is secured dockside. This issue was highlighted during a recent casualty whereby the owner of a passenger vessel had installed decorative Holiday type LED (Light Emitting Diode) lighting around the periphery of the vessel. The LEDs were contained in a clear flexible hose and securely attached. Near the bow of the vessel the lighting was adjacent and slightly above the port and starboard navigation lights. At night this installation, can impair the “distinctive character” of the navigation lights as set out in Rule 20 of the Navigation Rules. (Photograph below shows daytime view.)

Additionally, Rule 22 of Navigation Rules states that vessel sidelights have a two mile range for vessels 12 meters or more in length but less than 50 meters in length. In this particular casualty a side light navigation fixture was found installed on the passenger vessel that was stamped 1 nautical mile vice two miles. Vessel owners and operators and marine inspection personnel should ensure that the proper navigation lighting fixtures are installed, that all components operate correctly and that regulatory requirements with respect to Navigation Lighting are met.

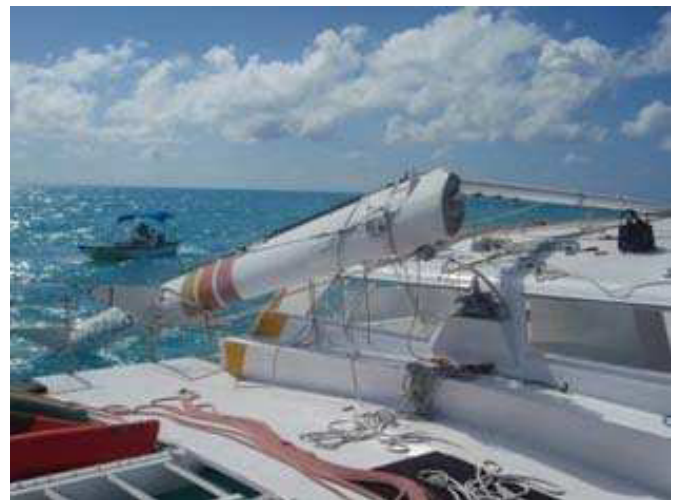
Common among the dismasting casualties was the failure of the mast's standing rigging. While this investigation is ongoing, initial forensic metallurgical analysis of the failed cable strands showed visual corrosion and evidence of fatigue failure. The shroud cable and swageless end fitting had been installed seven years prior.

The Coast Guard **strongly reminds** all commercial vessel owners/operators, especially those of passenger carrying sailing catamaran's of similar build, of their responsibility to maintain their vessels, associated equipment, systems and components in a satisfactory condition suitable for their employed service at all times. Owner and operators should not wait until regularly scheduled Coast Guard inspections to identify problems but should be ever vigilant and implement routine inspection, maintenance, and repair procedures in accordance with good marine practice and in alignment with applicable requirements. Owners and operators should consult the vessel manufacturer or other naval architecture, marine engineering services or qualified rigger regarding any concerns they might have regarding the regular flexing and working of their vessel's standing rigging

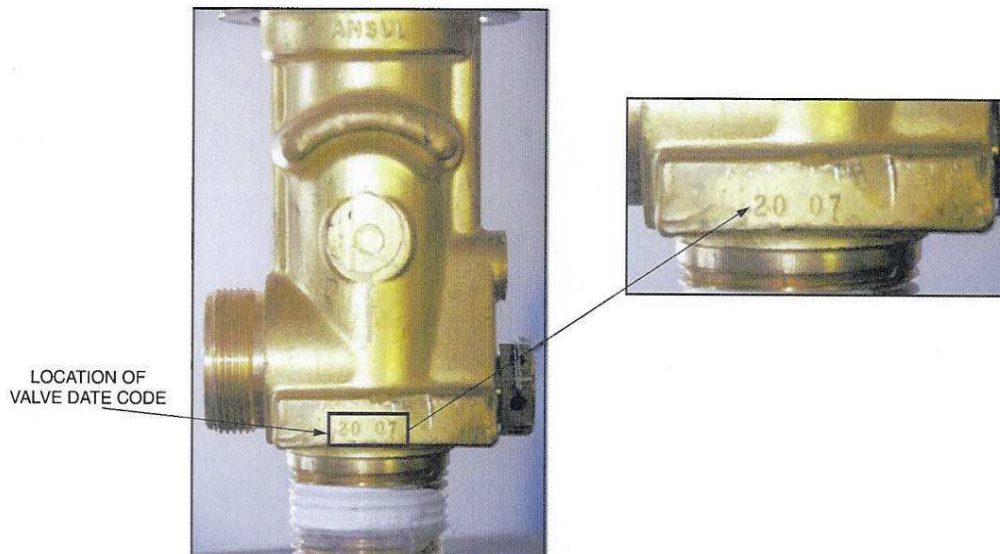
**Marine High Pressure CO<sub>2</sub> valves with a date code range of 10-07 to 06-08.**

This date code range is conservative and may be further narrowed through additional testing. The date code is located on the flat opposite of the valve outlet. The date code represents the week and year the valve was manufactured.

Carbon dioxide cylinders which are installed, or could be installed on a ship with a valve date code between 10-07 and 06-08 **MUST** be identified. If you identify cylinders with valves in this date code range, please contact ANSUL Quality Assurance **IMMEDIATELY** for further information and authorization for replacement of these cylinders.

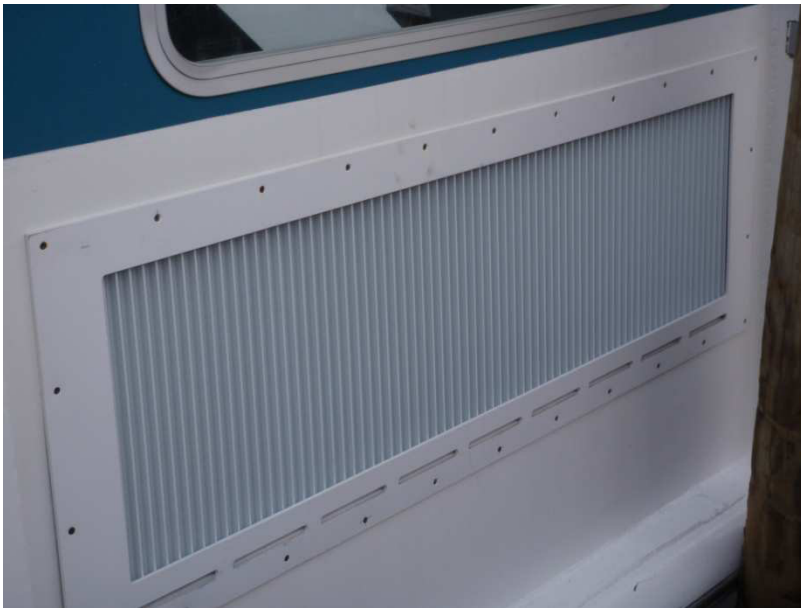
#### Polypropylene or PVC Components

When the extinguishing system was activated, all the dampers closed properly. However, after the fire it was noted that several external moisture eliminator filters were extremely damaged. The photo above shows an undamaged moisture eliminating filter. The actual size of this filter is about five feet by fifteen inches.

In this instance an improved installation may have involved mounting the sensors directly to a stable surface and attaching the sensors to the filter inlet using a flexible hose.

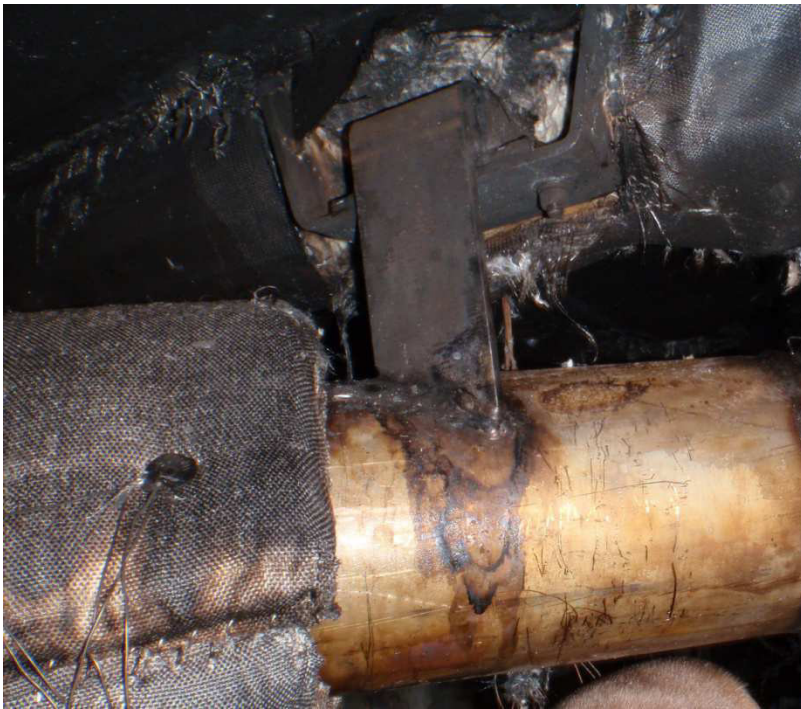
## Hot Spots

In a small engine room containing several engines and having a low overhead there are a number of locations that present enough heat to cause a fuel to flash and ignite other components. Turbocharger and exhaust piping insulation while serving to reduce heating of external areas also helps reduce the immediate availability of ignition hot spots. Care should be taken to ensure insulation wraps and blankets are kept tight and fastened in a manner to prevent dripping or spraying fluids from traveling to an exposed hot spot. Insulation seams should be made tight and where possible aligned in a manner to prevent pooling of fluid and to repel dripping. Likewise good marine practice may also dictate and ensure that braces which are welded directly to the exhaust pipe which serve as hangers or supports

also be insulated. Heat conducting from the exhaust pipe to the brace could be substantial allowing the exposed bracket to become nearly as hot as the exhaust pipe. The brace in the photo above was only partially covered with the insulation that was wrapped around the exhaust pipe. As with the other concerns in this document, owners and operators of any type vessel, as well as those persons involved with the inspection of vessels should be aware of the potential risks associated with improper or inadequate installation of insulation.

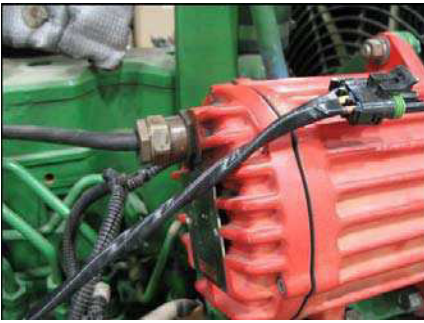
In some installations, cables between the alternator and battery were cut and a connector put in place to allow easier servicing. This alteration is not appropriate for hazardous locations. The cable seal on this alternator may not be the one approved for the alternator and may have to be examined.

Cable entries on flameproof or explosion proof enclosures require sealing fittings that are suitable for the enclosure.

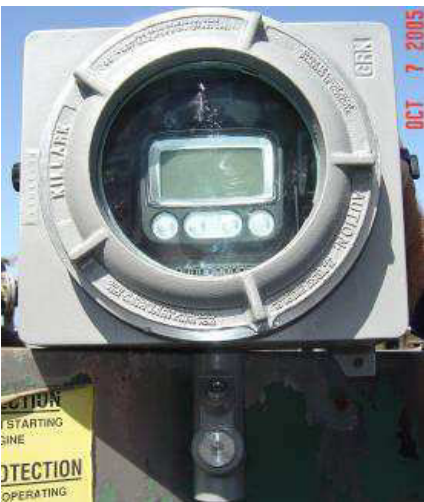
Typical unacceptable electronic display. This is not in an explosion proof enclosure. The beacon installation shown here outside of the enclosure is also unacceptable.

**Electronic displays** should be enclosed in explosion proof enclosures.

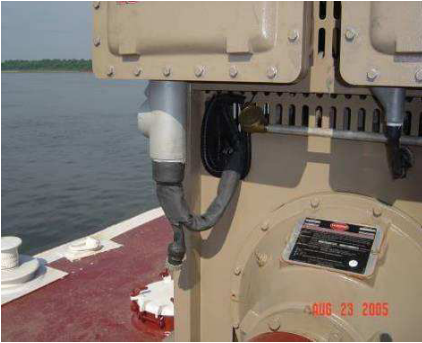
On this particular ECU, a large hole was drilled in the bottom of the enclosure with multiple wiring harnesses coming into it and installed without any sealing compound installed in the cable gland. This is not acceptable in hazardous locations.

**Engine control units (ECU) should be installed in an explosion-proof enclosure or outside the hazardous zone.**

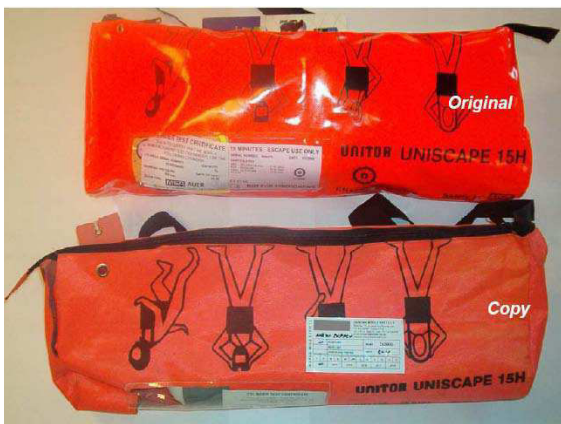
An authentic Unitor UNISCAPE 15H is contained in a shiny PVC bag. When viewed from the front with the instruction icons upside down, the zipper opens from left to right, and at the most left section of the zipper is a two centimeter gap covered by a clear tab that has a button closure.

The **fake reproduction** is contained within a **dull canvas-like** material bag. When viewed from the front with the instruction icons upside down, the **zipper opens from right to left**, and at the most left section of the zipper there is no opening, although a tab made of what appears to be the same material of the bag is present with a button closure. This unit will not automatically activate.
